Mining Management Plan 2018

Vista Gold Australia Pty Ltd

Mount Todd Gold Project

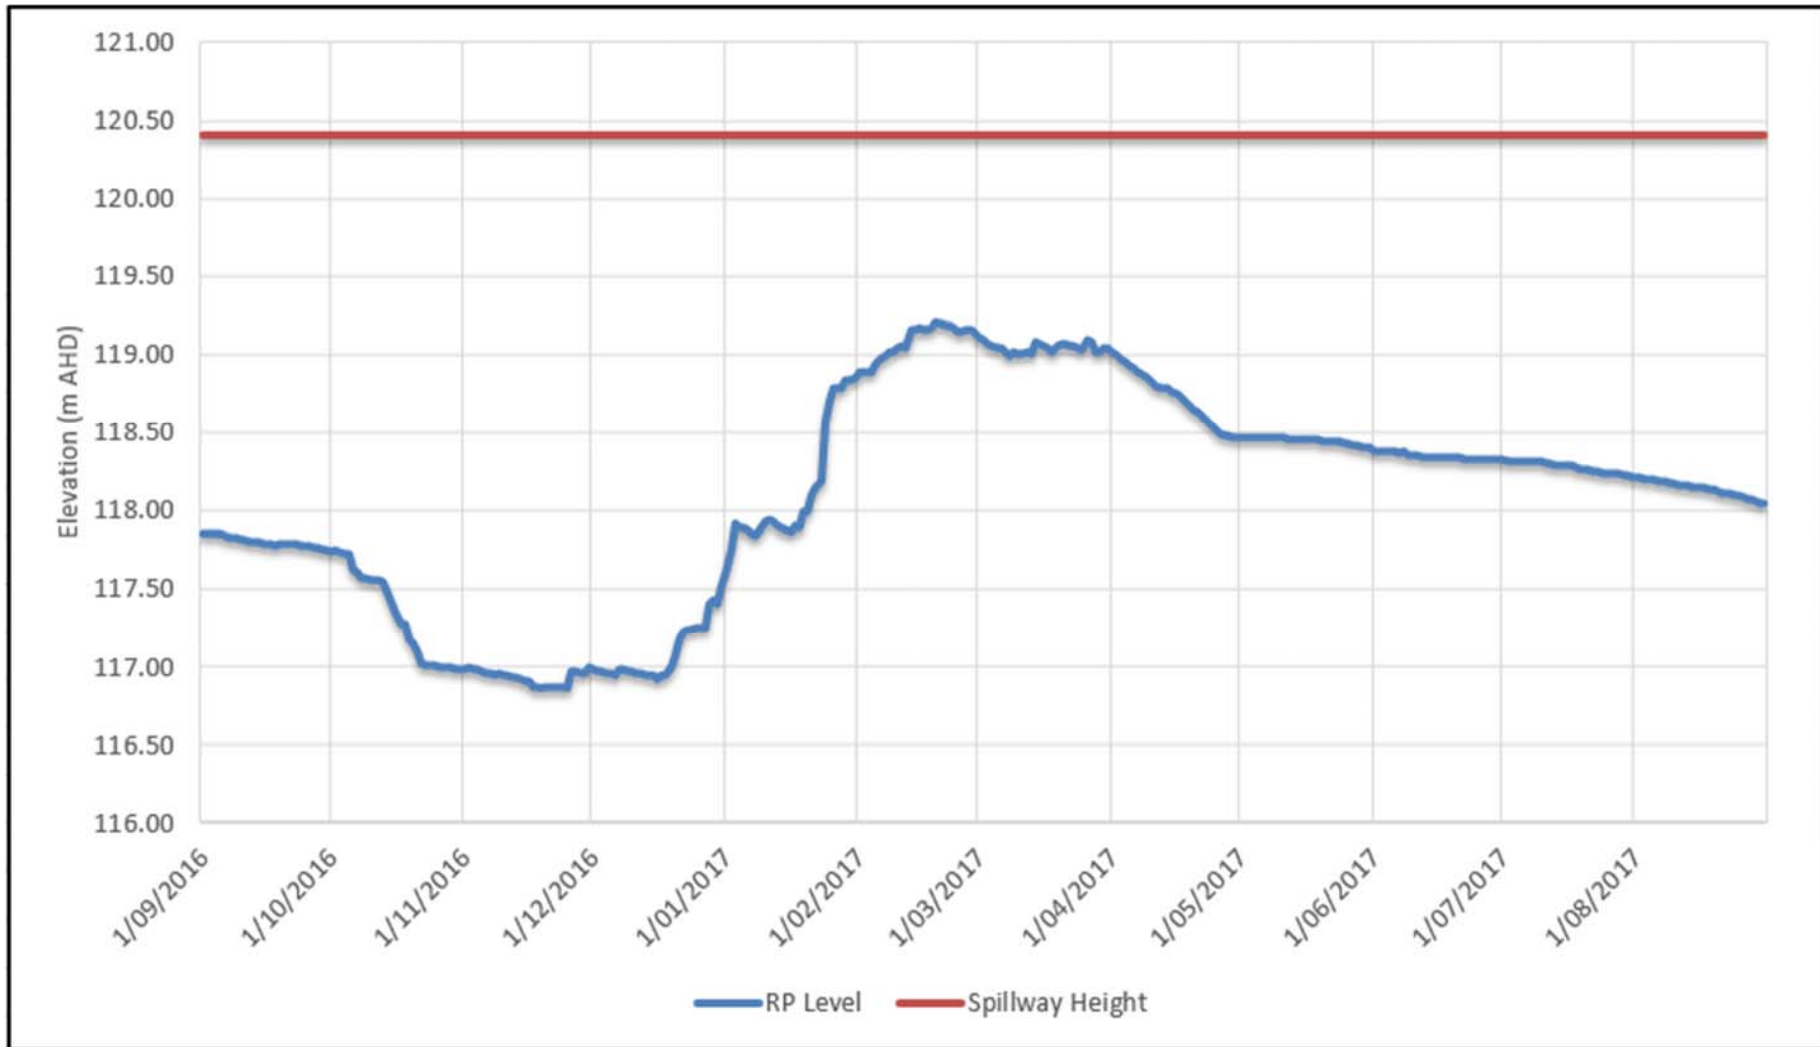
Water levels showed typical seasonal reductions. This level will be maintained to maximise evaporative losses prior to reducing the level in preparation for the 2018/2019 wet season.

The Heap Leach pond displayed maintenance pumping during the whole reporting period. Dry season top-ups to protect the pond liner and wet season pumping to prevent overflow were conducted.
